NONPOINT SOURCE PROGRAM SUCCESS STORY

New Mexico

Controlling Sediment Improves a Native Cutthroat Trout Stream

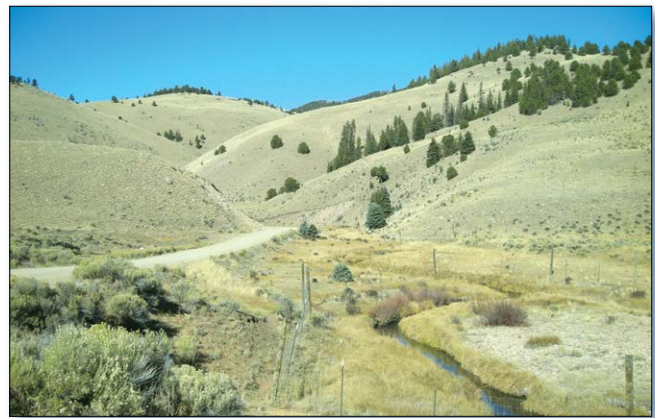
Figure 1. A restored section of Comanche Creek in the Valle Vidal unit of the Carson National Forest, 2012.

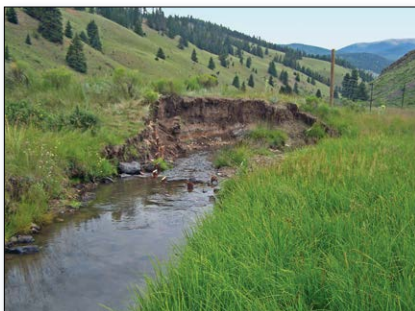
Figure 2. A cut bank on Comanche Creek, before treatment.

In 1991 NMED and Carson National Forest cooperated on a CWA section 319 grant project that stabilized erosion along Comanche Creek. In 2001 and 2004, NMED awarded CWA section 319 grants to the Quivira Coalition, a local nonprofit organization, to implement restoration work in Comanche Creek. The projects included installing more than 50 small exclosures to restrict elk and cattle grazing, 130 post vanes (a series of posts pounded into the streambed to deflect water flow away from the streambank), several Zuni

bowl rock structures (rock-lined step pools) to arrest headcut migration, and 75 upland structures to control erosion (Figures 2 and 3). Project partners also improved drainage and culverts on eight miles of road, planted willows and sedges, and conducted planning, design, coordination and monitoring. The Quivira Coalition conducts annual workshops that engage volunteers in maintaining the exclosures and other structures.

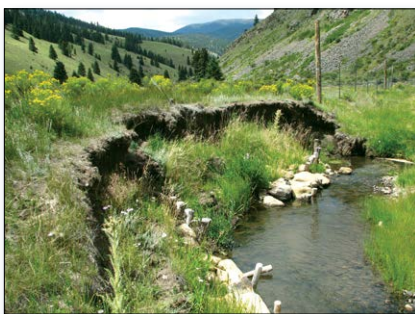
Figure 3. The same cut bank on Comanche Creek, after installation of post vanes.
