WATERSHED RESTORATION ACTION STRATEGY (WRAS)

COMANCHE CREEK WATERSHED

The Quivira Coalition

September 2005

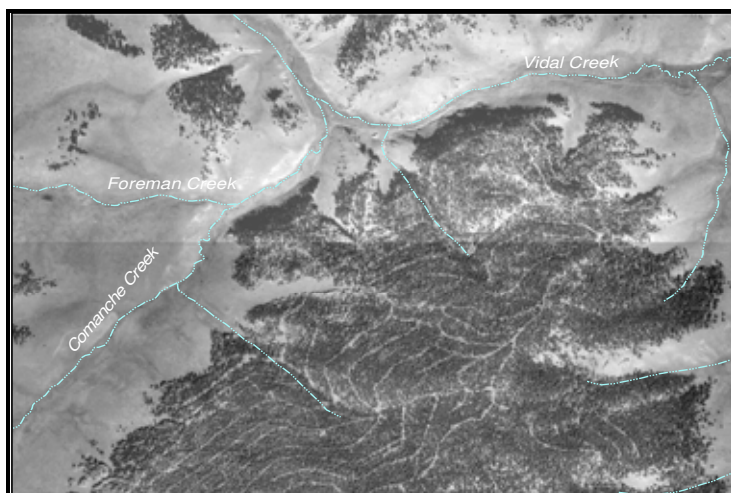
Figure 1. Roads from jammer logging near the confluences of Comanche Creek with Forman and Vidal Creeks. DOQQs from the late 1990s are courtesy of USFS Carson National Forest. The line across the middle of the picture is the join between two aerial photographs.

The Vermejo Park Ranch property was also heavily logged using a method called jammer logging. This method uses a cable and winch system to drag or skid logs uphill to a collection and loading area (Stokes et al 1989:16). Jammer cables have a reach of only 100 to 300 feet, so jammer logging requires the construction of closely spaced roads or terraces. **This method put a new road every 150 feet up many hillsides.** These road networks are clearly visible in aerial photos today (Figure 1).

Logging in the watershed continued into the late twentieth century. Road construction associated with logging created numerous small and large cuts and fills. Many of these roads remain unstable with sparse natural vegetation recovery. The condition of these areas ranges from at-risk for severe erosion to severely eroded. In addition, culverts have been installed in numerous locations within Comanche Creek itself and in some instances contribute to erosion and sediment loading in Comanche Creek. A sawmill was located in the Chuckwagon and Fernandez catchments. These areas appear to be major contributors of sediment.

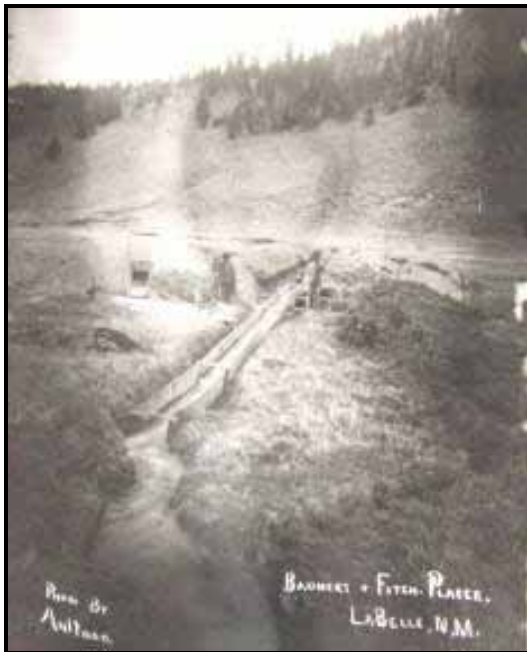
Figure 2. Mine and Sluice on La Belle Creek, circa 1890s (photo courtesy Carson National Forest).

Placer gold deposits were discovered in La Belle Creek in 1870 (USFS 1983) and the mining town of La Belle grew up around the mine site (Figures 2 and 3). Mining in the area continued into the late 1800s. Placer deposits are basically gravels containing gold particles. Placer mining exploits river and stream bottom deposits using pans, rockers, and sluices, and often involved diversion of the stream from its original channel.

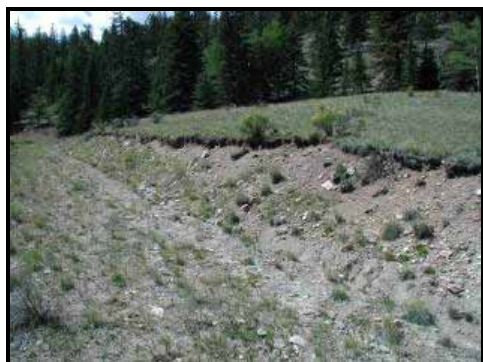
Figure 4. Road cut beginning to revegetate.

Under Forest Service management approximately ~300 miles of road have been closed in the Valle Vidal since 1982. Approximately 42 miles remain open for public access and approximately 100 miles of road have had no work done to them in 15 years. Many of the closed roads have revegetated naturally (see Figure 4) and are stable, but some are still major contributors of sediment to Comanche Creek.

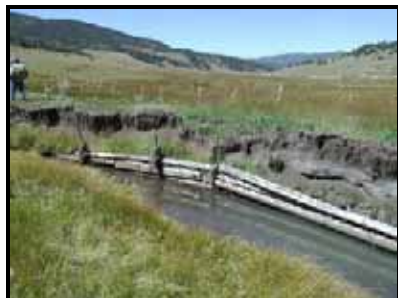
Figure 6. Revetment structure in Comanche Ccreek built in the late 1980s.

There have been a variety of efforts to stabilize and improve habitat along Comanche Creek and they have resulted in mixed levels of success. Revetment structures and small wood and rock in-stream habitat structures installed in the mid to late 1980s (see Figure 6) failed rapidly. Failure most likely was due to improper design, placement, and construction relative to channel characteristics, and the inability to withstand heavy stream flows during spring and summer rain events.

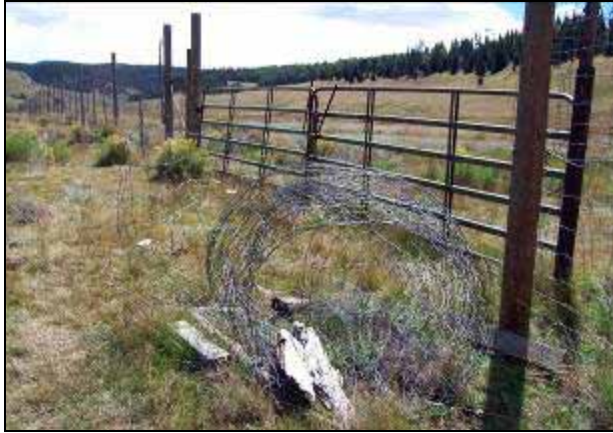
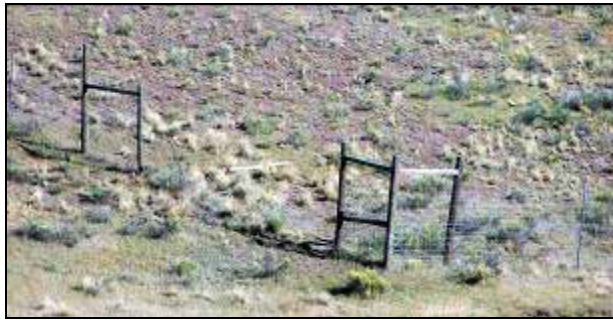
Figure 7. Pipe gate on large enclosure – this gate is too low to effectively exclude elk. Figure 8. South-east corner of fence is down allowing for cattle and elk access. Photos taken September 2005.

Cattle exclosures and separate elk/cattle exclosures constructed in the 1980s and 1990s were effective, but are now in need of repair or replacement. Three large exclosures were constructed in the mid-1980s that together enclose roughly 85 acres. Only the large exclosure (on the west side of Gold Creek in the middle reach) is in a semi-functional state. During a September 2005 visual assessment, the south-east corner was down and the gate is low enough to allow for elk use. Evidence of recent use by both elk and cattle were observed inside the exclosure (Figures 7, 8, and 9). With improvements in replacement materials and sustained maintenance these exclosures will become more effective at vegetation regeneration. The other two exclosures (close to the intersection of Little Costilla drainage) are completely non-functional and it may prove worth while to remove the old fencing materials.

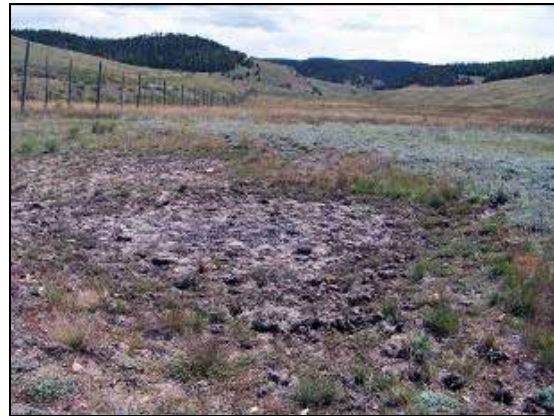
Figure 9. Overgrazed and trampled vegetation shows evidence of use by elk and or cattle inside the large Gold Creek enclosure, September 2005.

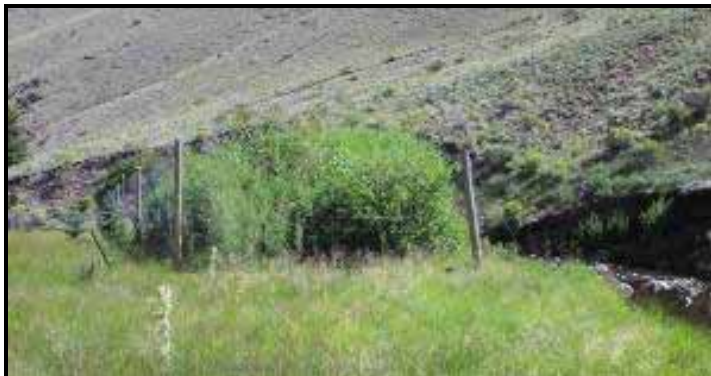
Figure 10. Woody riparian vegetation growing within a mini cattle/elk exclosure built in the 1990s (photo taken August 2002)

In 1991 the New Mexico Environment Department and Carson National Forest cooperated in using a CWA section 319(h) grant from the U.S. EPA to stabilize erosion along Comanche Creek (NMED 1996). Because large exclosures may interfere with the natural migration patterns of the elk, and elk are less likely to jump into a smaller/confined space, five small, “point-bar” exclosures installed in 1994 remain in place and have been successful at propagating woody vegetation, especially willows. Efforts to plant cottonwood poles have had little success. However, small exclosures constructed to protect existing willow plants provided a safe haven for the natural regeneration and establishment of cottonwoods and willows in the lower reach of Comanche Creek (Figure 10). Numerous cottonwood and willow volunteers have sprouted and survived within these exclosures. During the May 2005 high water event, these exclosures held up well and only required minor repairs.

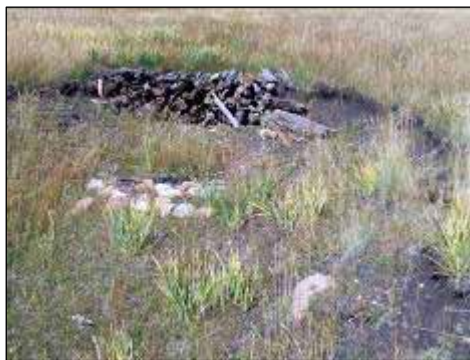
Figure 12. A log and fabric structure installed in the Holman Creek wet meadow, September 2003.

Upland erosion control treatments installed along side drainages of Comanche creek are designed to slow the movement of water, collect soil, nourish vegetation and prevent sediment from entering the creek. Examples include One Rock Dams, Rock Baffles, Rock Bowls, Worm Ditches and a Log and Fabric Headcut Control Structures (Figures 11-12). In 2002-2003 171 erosion control structures were installed during on-the-ground educational workshops using volunteer labor.

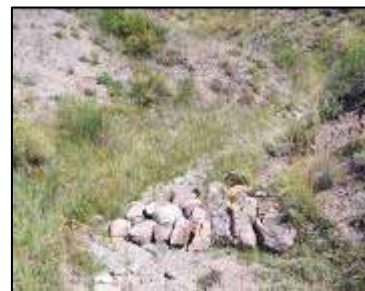
Figure 11. A Rock Baffle on Comanche Point Gully, installed September 2003.

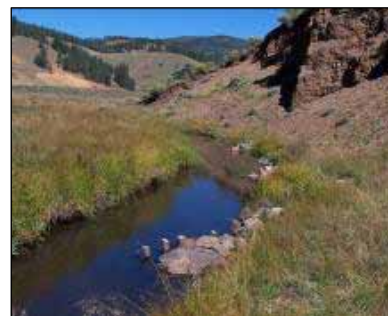
Figure 13. Three Vanes installed along an eroding bank during a 2004 work shop (Photo taken September 2005)

Instream treatments consist primarily of vanes and rock plugs. Vanes are wooden posts or rock structures installed at strategic locations in Comanche Creek to direct stream flow left or right, away from eroding banks to reduce sediment production and promote streambank vegetative growth. (Figure 13). Fifty-six vanes will be installed along the lower reach. There are currently seventeen vanes along eroding banks of the lower reach and thirty-nine are

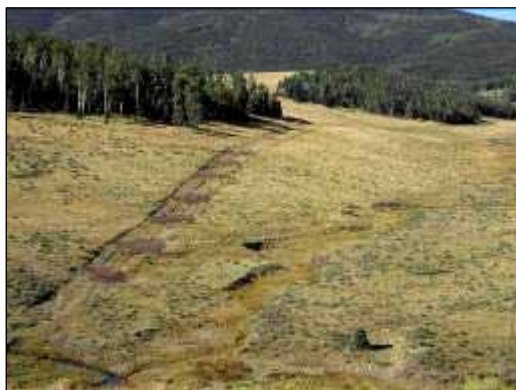
Figure 15. Rolling waterbars installed on an old road to the east of Gold Creek, September 2004.

Road surveys and treatments. In 2003, fifty miles of old logging roads and administrative roadways in the watersheds of Fernandez, Chuckwagon, Gold, Labelle, Little Costilla, Springwagon, Holman, Grassy and several intermingled, unnamed watersheds was inventoried. A Road Inventory Report by Bill Zeedyk (*Appendix 12*) determined that about 9 miles of roadways need erosion control treatment using heavy equipment and about 2 miles can be maintained using hand tools. The remaining forty miles need no follow-up treatment for erosion control purposes, or indicated sites are so scattered or marginal that cost of further treatment is not warranted. The most severely eroding roadways are in the Little Costilla, Chuckwagon, Holman and Gold Creek watersheds, although not all roadways in these drainages require treatment. Roadways in the Grassy Creek, Fernandez and Springwagon watersheds need no follow-up work at this time. Eight stream crossings (culverts) at inventoried sites were identified to be removed and replaced by low-water crossings to correct or avoid serious damage to the channel or floodplain. Treatment will require removing culvert pipes, excavating embankment material from channel and floodplain, stabilizing and vegetating dredged materials, installing rock low-water crossings and in some cases other incidental treatments. Failure to do so will result in downcutting and erosion of the stream channel and streambanks, and headcutting all contributing to chronic sources of sedimentation and turbidity. Needed culvert extractions include four sites on Chuckwagon, two on Little Costilla, one on Gold and perhaps one on Fernandez. As a result of the road inventory report, during July – September 2004, 11.7 miles of road were rehabilitated to reduce sediment sources in the watershed with the following treatments implemented.

- ❖ 0.2 mi. road completely restored to natural contours;
- ❖ 1 stream crossing rehabilitated to restore natural floodplain banks and decrease sediment from FS Administrative use road;
- ❖ 5.2 miles (approx.) stabilized with rolling grade dips & waterbars;
- ❖ 2 culverts removed that were affecting the stream channel;
- ❖ 1 culvert plugged - not needed for road drainage and better handled; surface flows with a grade dip;
- ❖ 2 culverts functionality improved with install of associated grade dips;
- ❖ Holman Creek (old timber sale access road) 1.3 miles (approx.) stabilized with rolling grade dips & waterbars;
- ❖ Gold Creek 1.8 miles (approx.) stabilized with rolling grade dips & waterbars. (Figure 15); Chuckwagon Canyon 3.4 miles (approx.) stabilized with rolling grade dips & waterbars; and 1.0 miles road completely restored to natural contours.

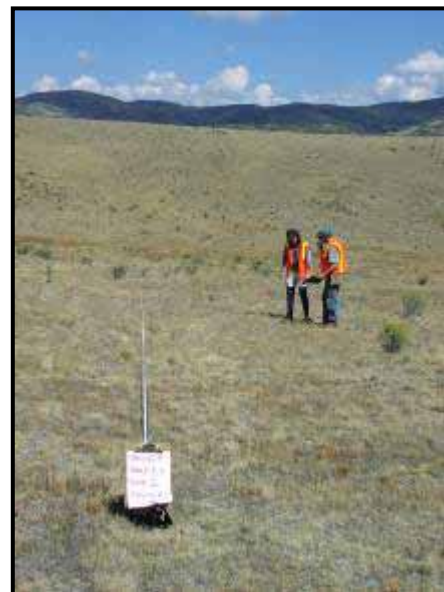
Figure 18. Upland Monitoring Photo Point in Upper Comanche Creek Watershed

1. Photo points – permanent photo points allow qualitative monitoring of vegetation and landscape changes through time.
2. Line-point intercept for vegetative cover and composition – this is a rapid, objective way of assessing ground cover consisting of vegetation, litter, rocks, and biotic crusts, and involves recording the types of cover encountered at regular points along each monitoring transect.
3. Gap intercept or substitution of measurement to nearest perennial plant – gap intercept measures the proportion of a monitoring transect covered by plant canopy. Spaces greater than 20 centimeters are considered gaps.

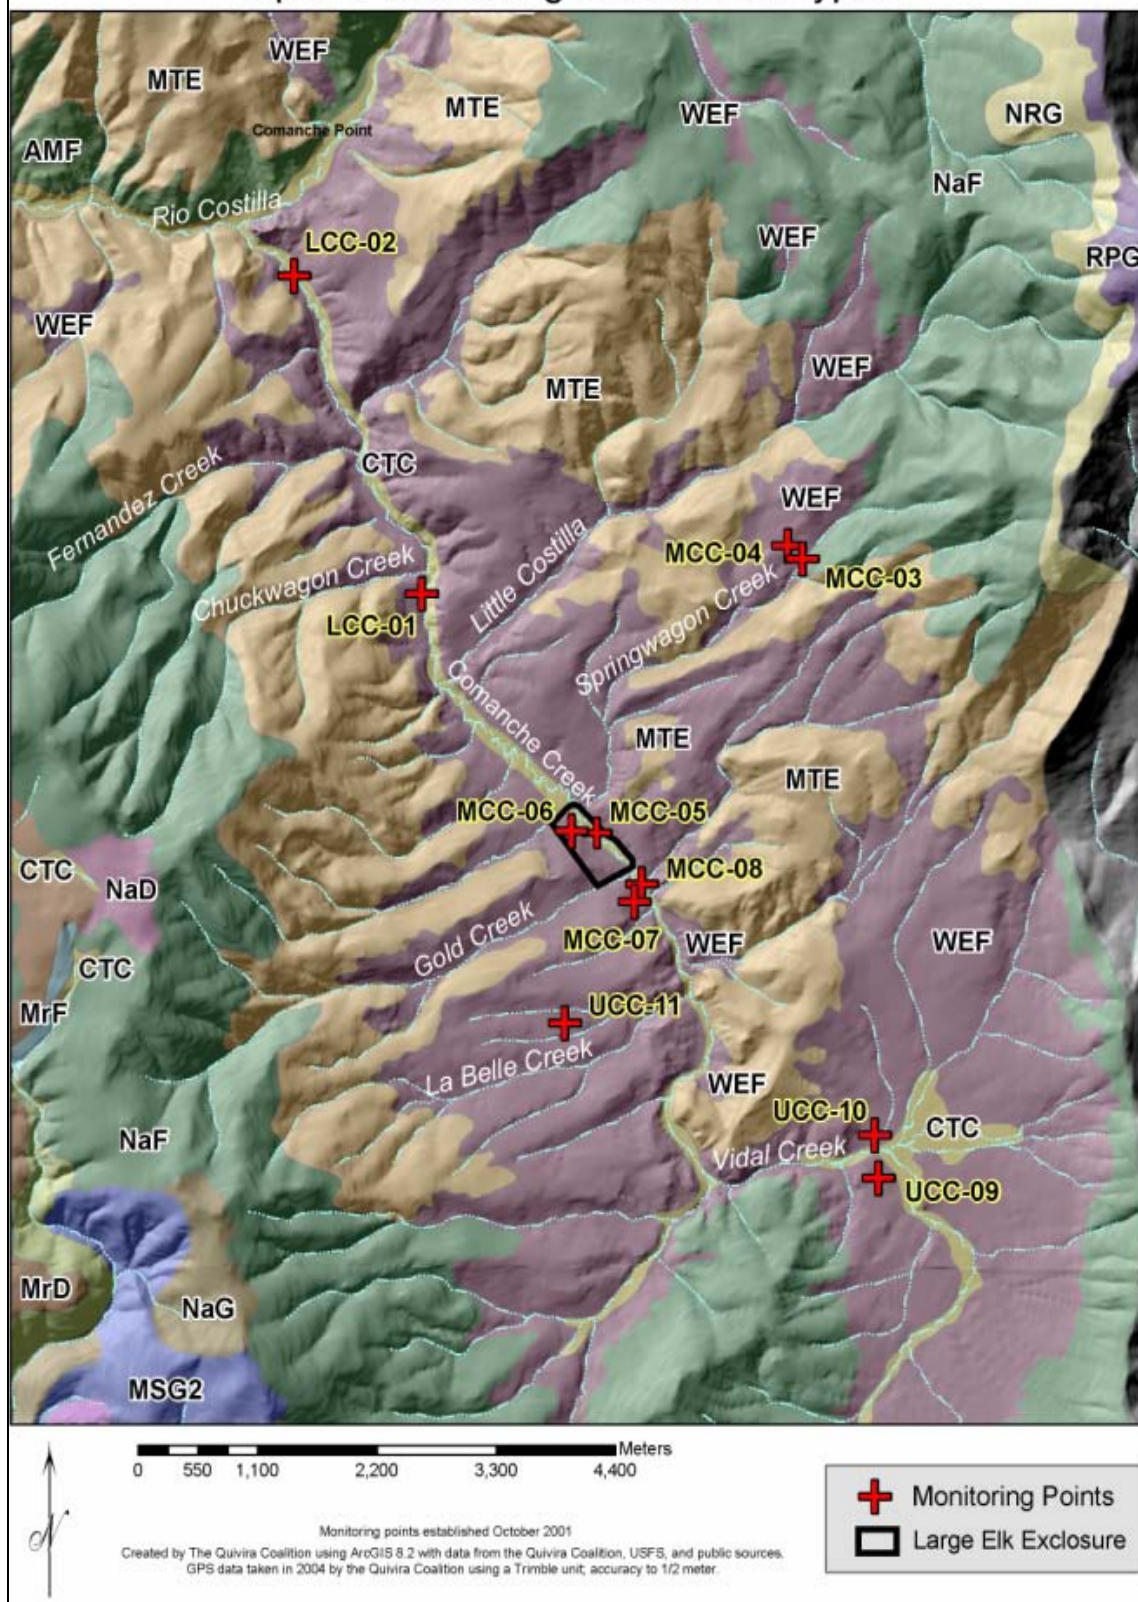
MAP C

Comanche Creek Upland Monitoring Sites & Soil Types
