Costs and Ecological Benefits of Organic Amendments Added to Erosion Control Structures

December 2023

Chase Hetler, Megan O'Connell, and Eva Stricker

Quivira Coalition

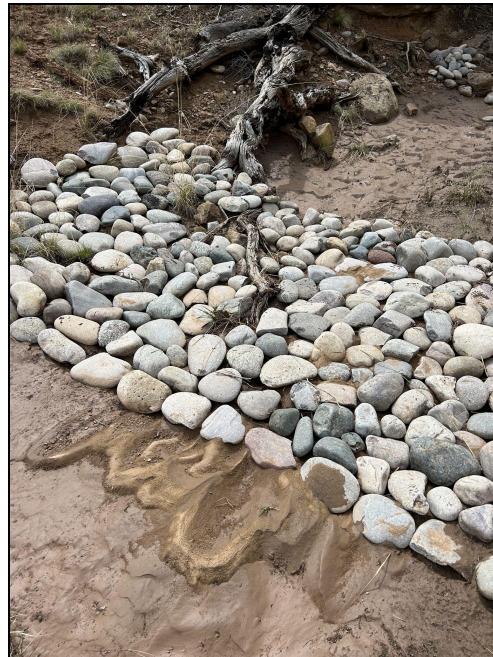
Figure 1: Rock rundown structure

Headcuts are vertical or near-vertical drops along the beds of erosion channels. They are steep elevation changes caused by water erosion and expose bare soil, making it even more susceptible to future water erosion.⁸ Rock rundowns are best utilized on low-energy headcuts (<1.5 ft tall) to prevent upstream erosion and stabilize the sites. When building the structure, it is important to modify the incline of the headcuts relative to surrounding soils so it is a stable angle (3:1 slope), and that the middle point is the lowest so that water runs through the structure and not around it. Live plant matter should be protected and the rocks should be placed as tightly as possible to avoid water contact with the soil of the head cut.⁹

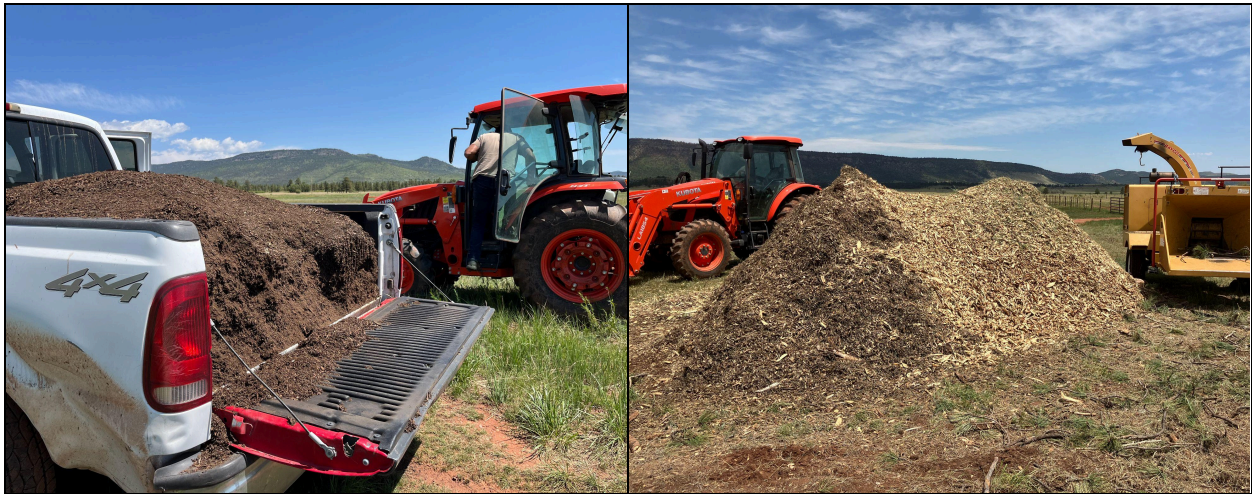
Figure 3: Left: Truck loaded with approximately 1-1.5 cubic yards of compost. Right: Mulch pile ready to be applied to site

Premium Compost was purchased from Soilutions in Albuquerque, NM. The compost was composed of approximately 46% organic matter and it had a pH of 8. It had a ratio of 0.62 of nitrogen, 0.31 of phosphorus, and 0.71 of potassium.²² The compost was applied above the erosion control structure at about 1/4 in depth and approximately .2 cubic yards were applied to each structure using a rake and wheelbarrow.

Wood mulch was purchased from Soilutions in Albuquerque, NM. The mulch consisted of chipped blonde wood. It was applied at approximately ¼ inch depth above the erosion control structure to create a blanket effect over the ground. Approximately 0.2 cubic yards of mulch was applied to each structure simply using a wheelbarrow and shovels.

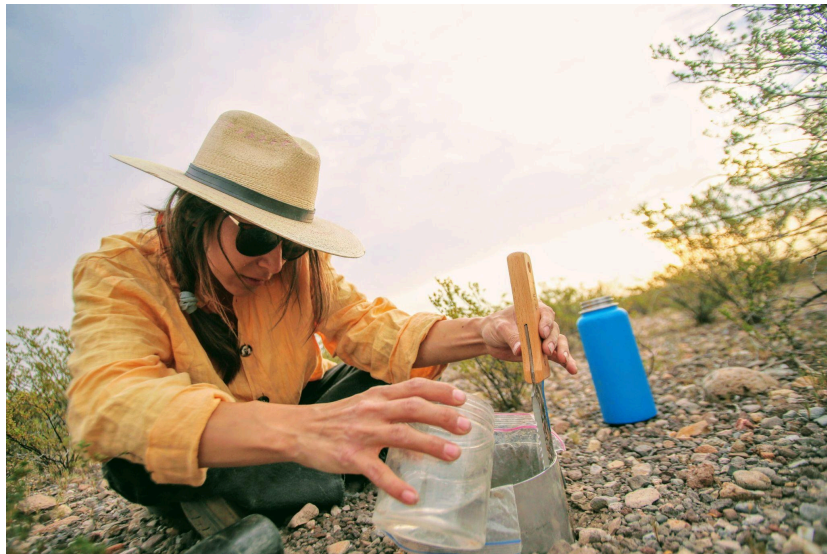
Figure 5: CRI Project Manager Garcia measures the infiltration rate of arid rocky soils.

- **Infiltration rate:** Infiltration rate is a measure of how fast water penetrates soil and is determined by soil texture, which is an inherent characteristic of the soil, and structure, which can change based on compaction, organic matter content, and other stressors. Water infiltrates more rapidly in drier soils, and as water begins to replace air in soil pores, the infiltration rate slows and eventually reaches a steady rate.²⁴ Infiltration rate was measured with a single ring infiltrometer (15 cm diameter) in a randomly selected interspace. 444 mL of water was added and the time for infiltration was recorded, then the process was repeated with a second 444 mL.

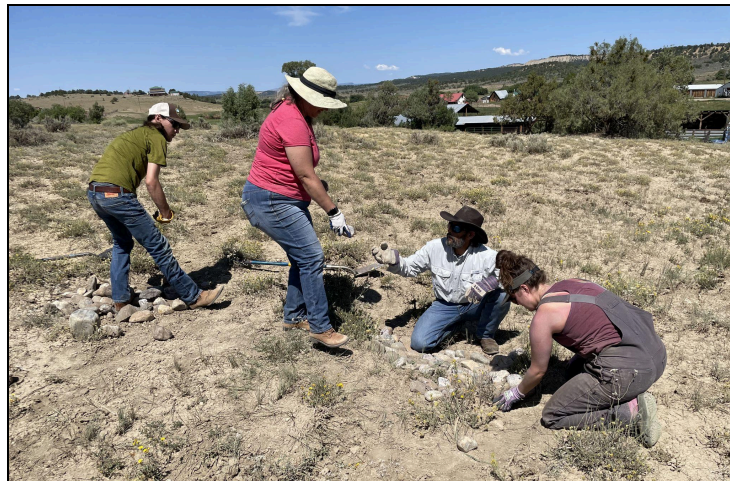
Figure 5: Participants learning how to construct rock rundown structures

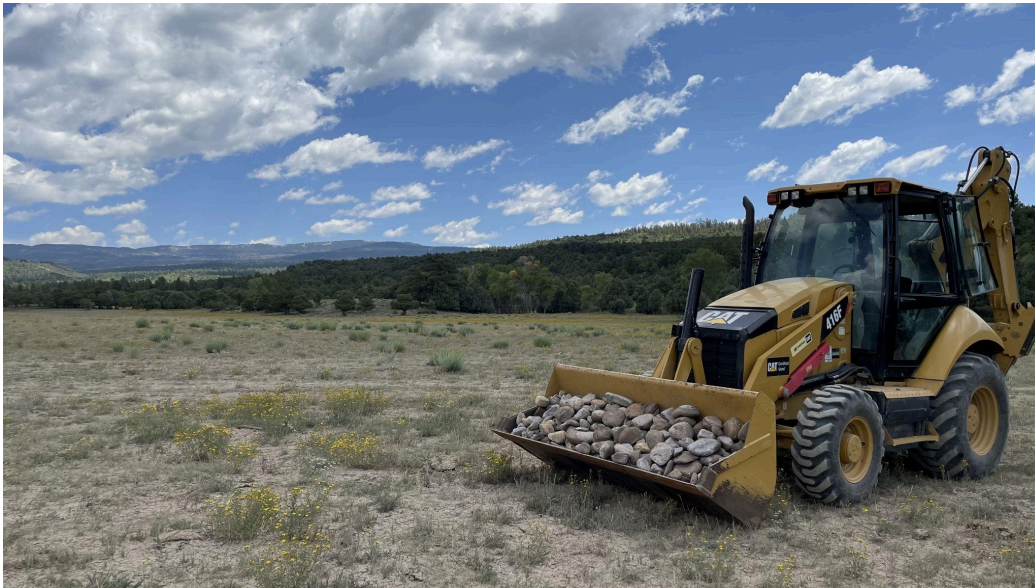
Figure 6: Backhoe transporting rocks to sites

In general, the usage of a backhoe did little to impact overall construction costs or reduce the hours required for assembly. For some properties, such as the Hibner Ranch, a backhoe was necessary to dislodge rocks embedded in the ground. Backhoes also reduce the amount of time and effort it takes to load and unload rocks. Otherwise, properties found that using equipment such as a truck or Four-wheeler was sufficient. Producers should determine what equipment to use to assemble structures based on how accessible rock is on the property, the distance rocks must be moved, the size of the rocks, and the number of workers available.

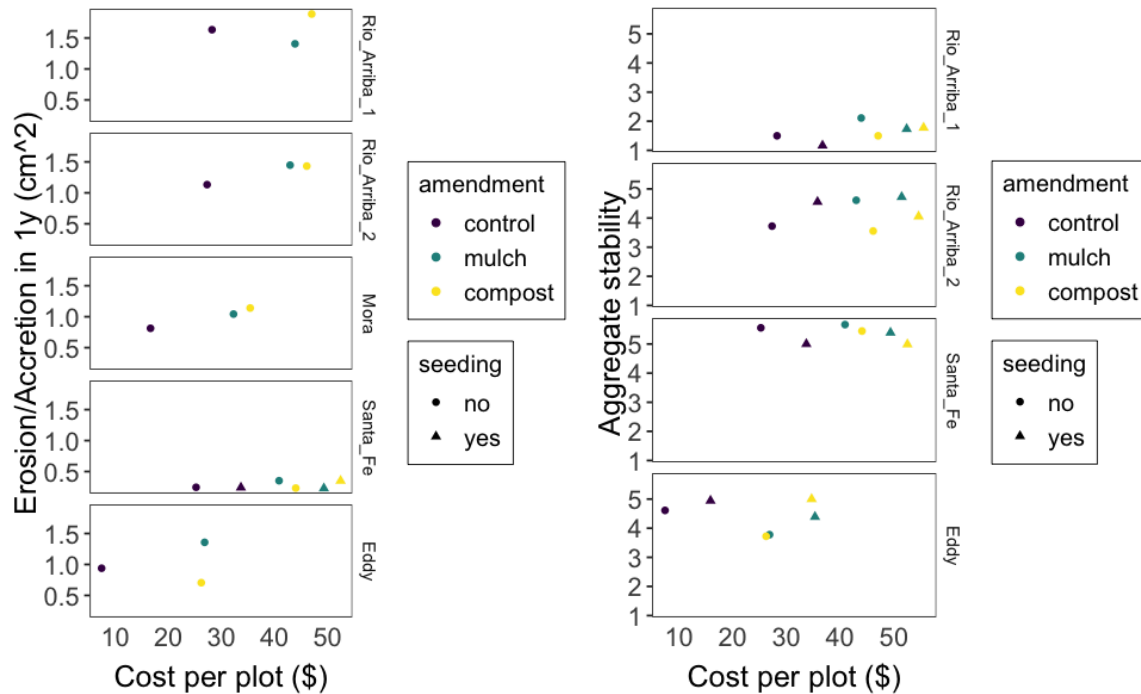
Figure 7. Cost of treatments (amendment = point colors and seeding = point shape) at each ranch. Left column: amount of soil that accumulated (positive numbers) or eroded (negative

numbers) from the channel below the rock rundown structure in one year. Right column: aggregate stability (higher values are more resistant to disruption in water than lower values) of soil upslope of the erosion control structure after one year.

Overall, we did not detect a significant difference in several of the ecological measurements we monitored across our treatments (Figures 7, 8, 9). In general, we found rock rundowns, on their own, to be effective tools for reducing erosion in active headcuts on arid lands throughout New Mexico because generally the channel below the structure gained material (positive numbers) rather than deepening or widening (Figure 7, left column).

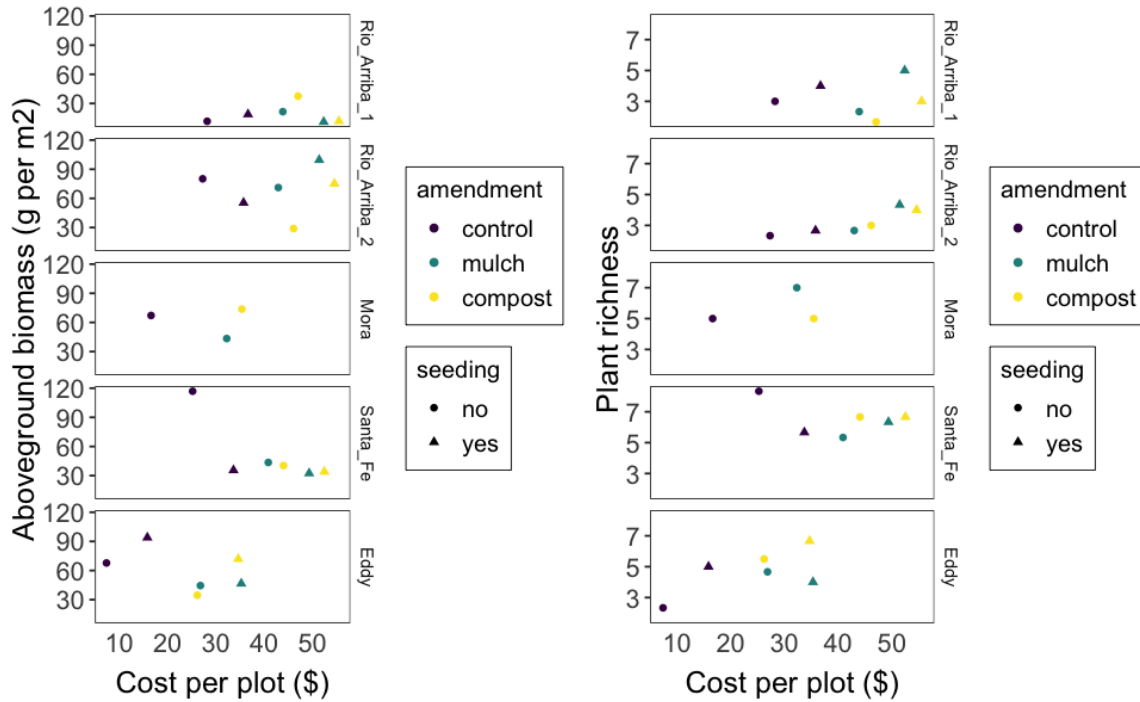
Figure 8. Cost of treatments (amendment = point colors and seeding = point shape) at each ranch. Left column: total biomass in plots upslope of the erosion control structure after one year. Right column: Plant richness (number of species encountered on the line intercept transect) in plots upslope of the erosion control structure after one year.

There were several sites with trends that increased costs of interventions led to a benefit in ecological response. For example, at Rio Arriba #2 and Santa Fe ranches, interventions of about \$20 more per plot led to approximately half the amount of bare ground (Figure 9, left column). However, in other cases, additional interventions seemed to decrease desired ecological characteristics, such as aboveground biomass at the Eddy county ranch (Figure 8, left column).

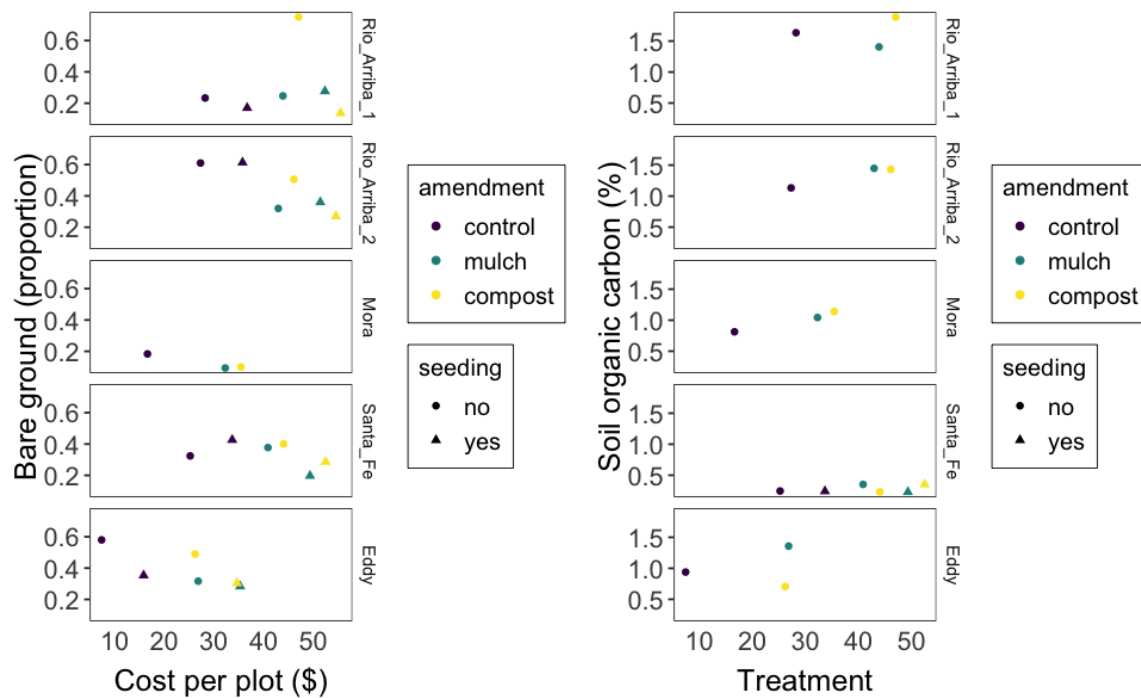
Figure 9. Cost of treatments (amendment = point colors and seeding = point shape) at each ranch. Left column: The amount of bare ground plots upslope of the erosion control structure after one year. Right column: Plant richness (number of species encountered on the line intercept transect) in plots upslope of the erosion control structure after one year.
