Costs and Ecological Benefits of Organic Amendments Added to Erosion Control Structures

December 2023

Chase Hetler, Megan O'Connell, and Eva Stricker
Quivira Coalition

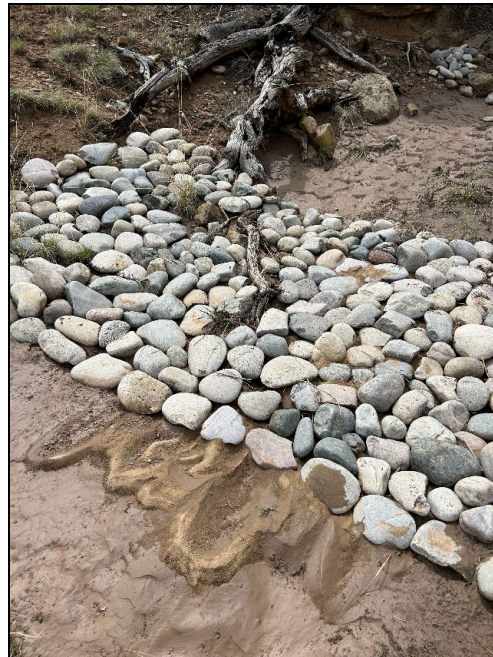
Figure 1: Rock rundown structure

Headcuts are vertical or near-vertical drops along the beds of erosion channels. They are steep elevation changes caused by water erosion and expose bare soil, making it even more susceptible to future water erosion.⁸ Rock rundowns are best utilized on low-energy headcuts (<1.5 ft tall) to prevent upstream erosion and stabilize the sites. When building the structure, it is important to modify the incline of the headcuts relative to surrounding soils so it is a stable angle (3:1 slope), and that the middle point is the lowest so that water runs through the structure and not around it. Live plant matter should be protected and the rocks should be placed as tightly as possible to avoid water contact with the soil of the head cut.⁹

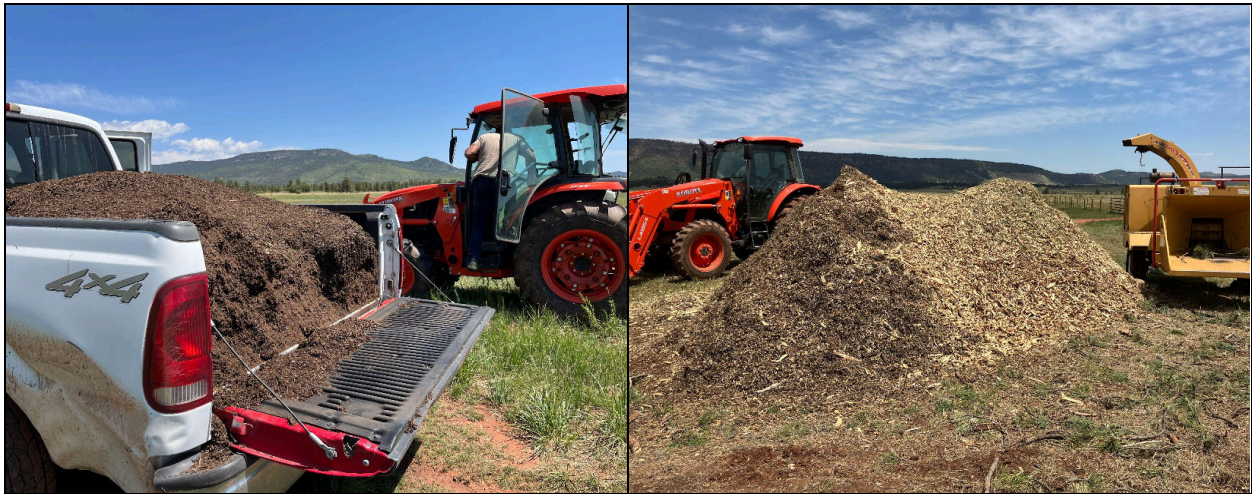
Figure 3: Left: Truck loaded with approximately 1-1.5 cubic yards of compost. Right: Mulch pile ready to be applied to site

Premium Compost was purchased from Soilutions in Albuquerque, NM. The compost was composed of approximately 46% organic matter and it had a pH of 8. It had a ratio of 0.62 of nitrogen, 0.31 of phosphorus, and 0.71 of potassium.²² The compost was applied above the erosion control structure at about 1/4 in depth and approximately .2 cubic yards were applied to each structure using a rake and wheelbarrow.

Wood mulch was purchased from Soilutions in Albuquerque, NM. The mulch consisted of chipped blonde wood. It was applied at approximately 1/4 inch depth above the erosion control structure to create a blanket effect over the ground. Approximately 0.2 cubic yards of mulch was applied to each structure simply using a wheelbarrow and shovels.

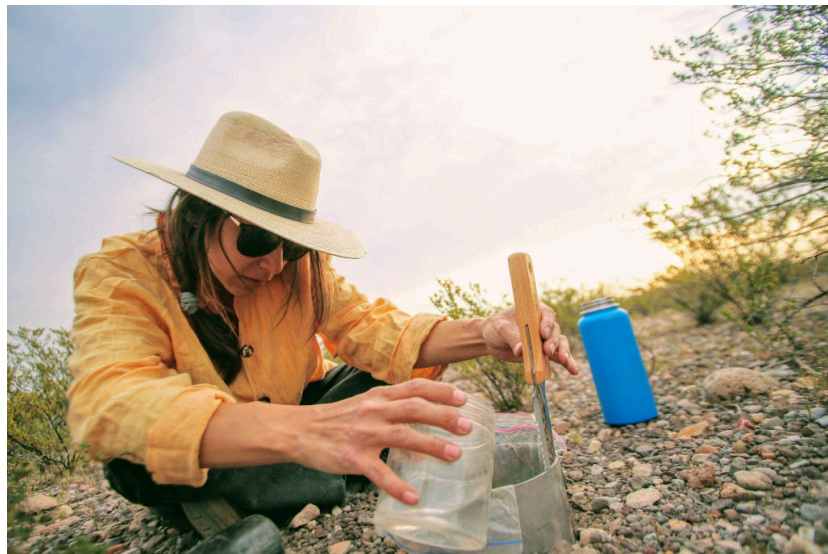
Figure 5: CRI Project Manager Garcia measures the infiltration rate of arid rocky soils.

- Infiltration rate: Infiltration rate is a measure of how fast water penetrates soil and is determined by soil texture, which is an inherent characteristic of the soil, and structure, which can change based on compaction, organic matter content, and other stressors. Water infiltrates more rapidly in drier soils, and as water begins to replace air in soil pores, the infiltration rate slows and eventually reaches a steady rate.²⁴ Infiltration rate was measured with a single ring infiltrometer (15 cm diameter) in a randomly selected interspace. 444 mL of water was added and the time for infiltration was recorded, then the process was repeated with a second 444 mL.

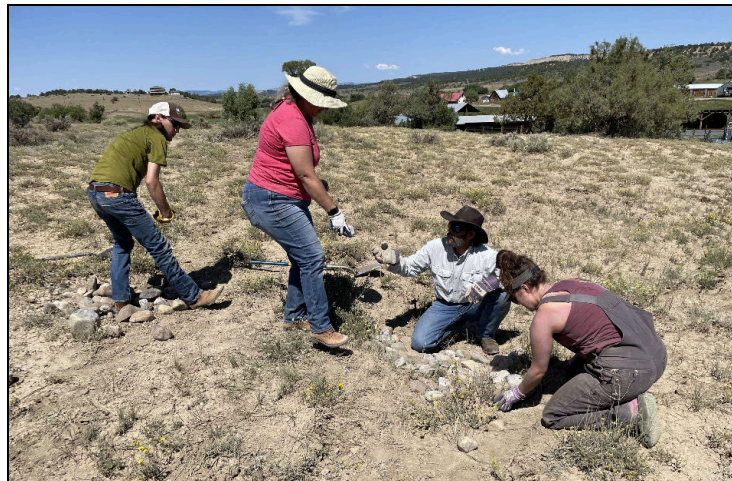
Figure 5: Participants learning how to construct rock rundown structures

Some ranches hosted a workshop during which up to 20 participants helped build the rock structures. In this analysis, we are considering every voluntary participant in building the structures to be a paid employee, and that volunteers worked about half of the total construction time reported by participating ranchers. So, for the purposes of estimating a consistent average cost per structure across all 5 ranches, we are choosing to include the labor costs of workshop participants, although in reality, voluntary participants were not paid to assist at the workshops. Hosting these educational events actually provided many hours of volunteer labor towards building the structures and could be a viable cost-saving mechanism for other ranchers looking to build rock rundowns on their land. Hosting workshops is also an effective way to share knowledge and build community between ranchers. This benefit is not quantified in this study, but is crucial to note nevertheless.

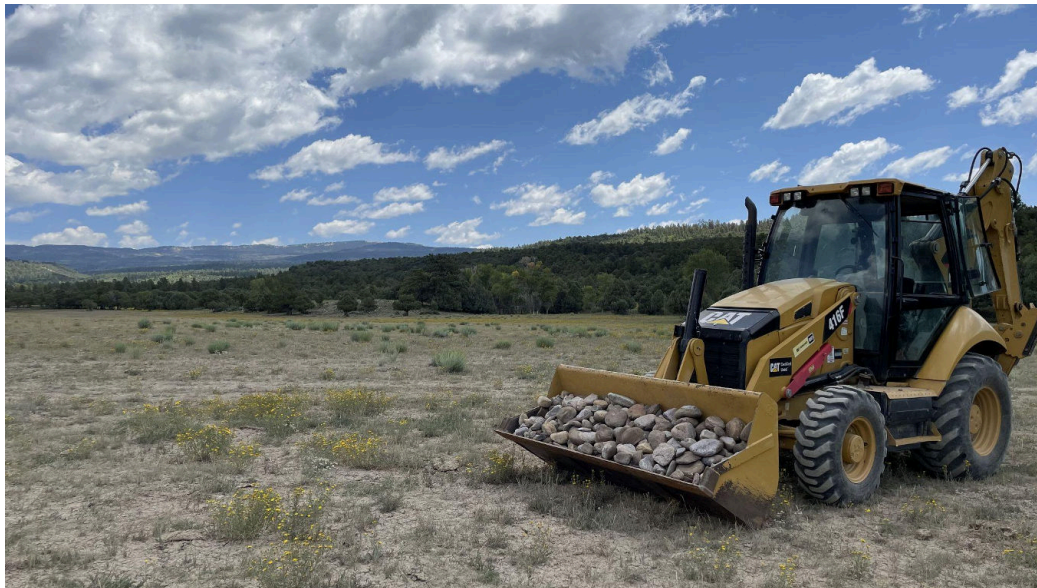
Figure 6: Backhoe transporting rocks to sites

In general, the usage of a backhoe did little to impact overall construction costs or reduce the hours required for assembly. For some properties, such as the Hibner Ranch, a backhoe was necessary to dislodge rocks embedded in the ground. Backhoes also reduce the amount of time and effort it takes to load and unload rocks. Otherwise, properties found that using equipment such as a truck or Four-wheeler was sufficient. Producers should determine what equipment to use to assemble structures based on how accessible rock is on the property, the distance rocks must be moved, the size of the rocks, and the number of workers available.

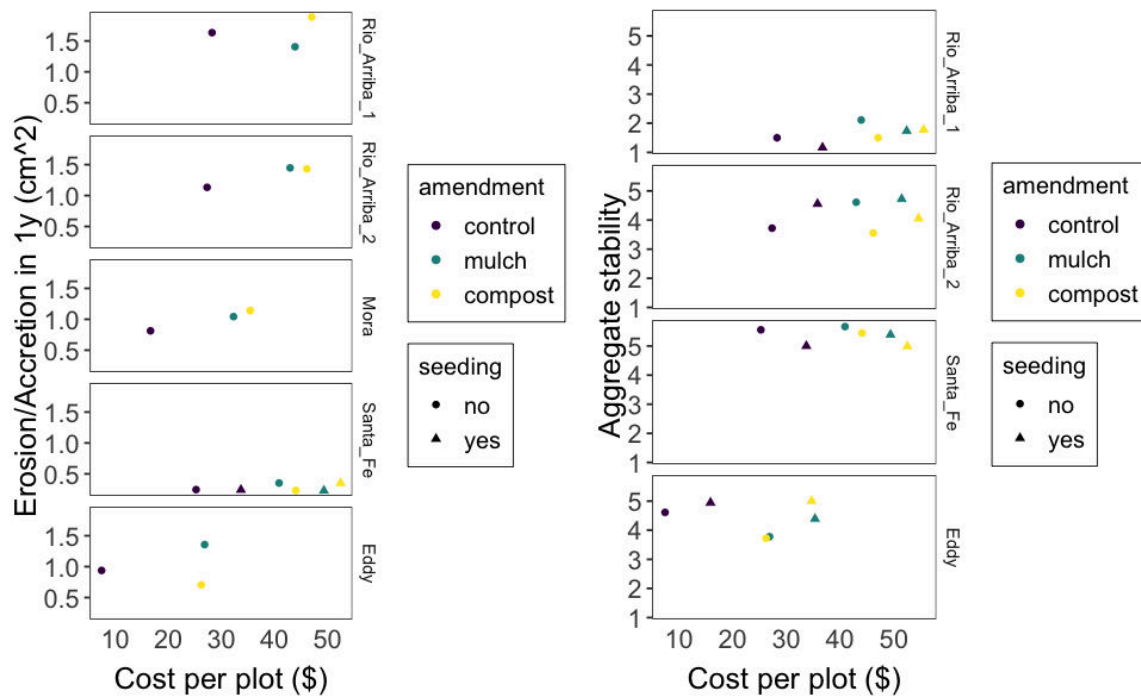
Figure 7. Cost of treatments (amendment = point colors and seeding = point shape) at each ranch. Left column: amount of soil that accumulated (positive numbers) or eroded (negative

numbers) from the channel below the rock rundown structure in one year. Right column: aggregate stability (higher values are more resistant to disruption in water than lower values) of soil upslope of the erosion control structure after one year.

Overall, we did not detect a significant difference in several of the ecological measurements we monitored across our treatments (Figures 7, 8, 9). In general, we found rock rundowns, on their own, to be effective tools for reducing erosion in active headcuts on arid lands throughout New Mexico because generally the channel below the structure gained material (positive numbers) rather than deepening or widening (Figure 7, left column).

There were several sites with trends that increased costs of interventions led to a benefit in ecological response. For example, at Rio Arriba #2 and Santa Fe ranches, interventions of about \$20 more per plot led to approximately half the amount of bare ground (Figure 9, left column). However, in other cases, additional interventions seemed to decrease desired ecological characteristics, such as aboveground biomass at the Eddy county ranch (Figure 8, left column).

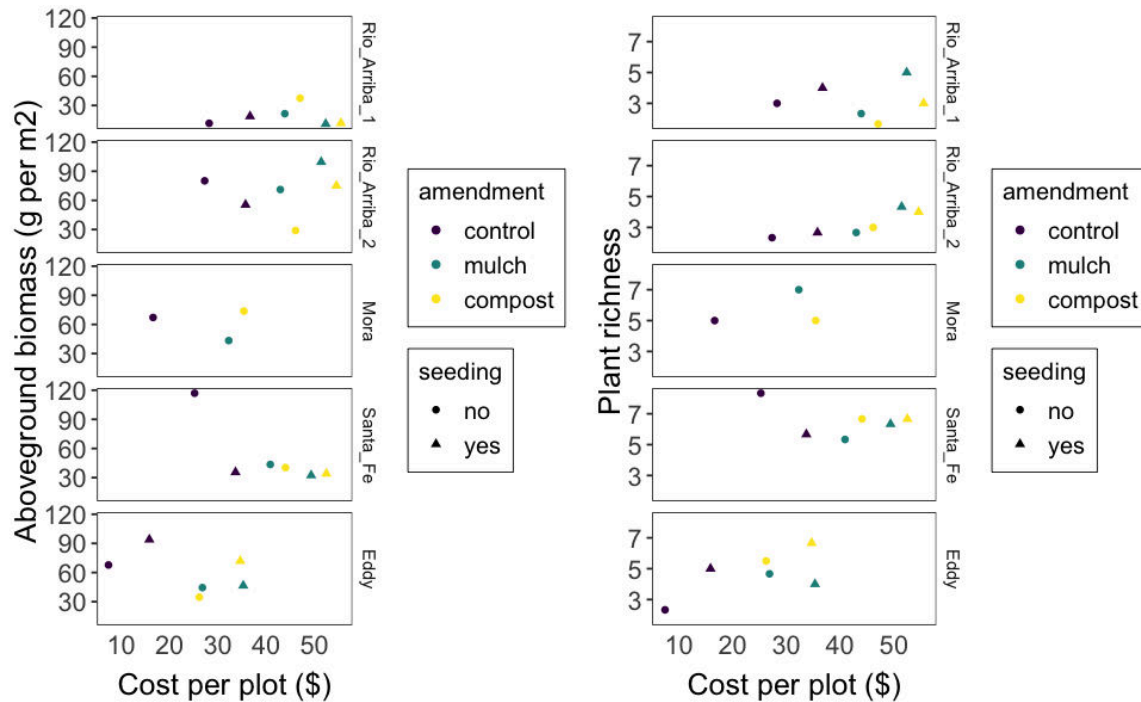
Figure 8. Cost of treatments (amendment = point colors and seeding = point shape) at each ranch. Left column: total biomass in plots upslope of the erosion control structure after one year. Right column: Plant richness (number of species encountered on the line intercept transect) in plots upslope of the erosion control structure after one year.

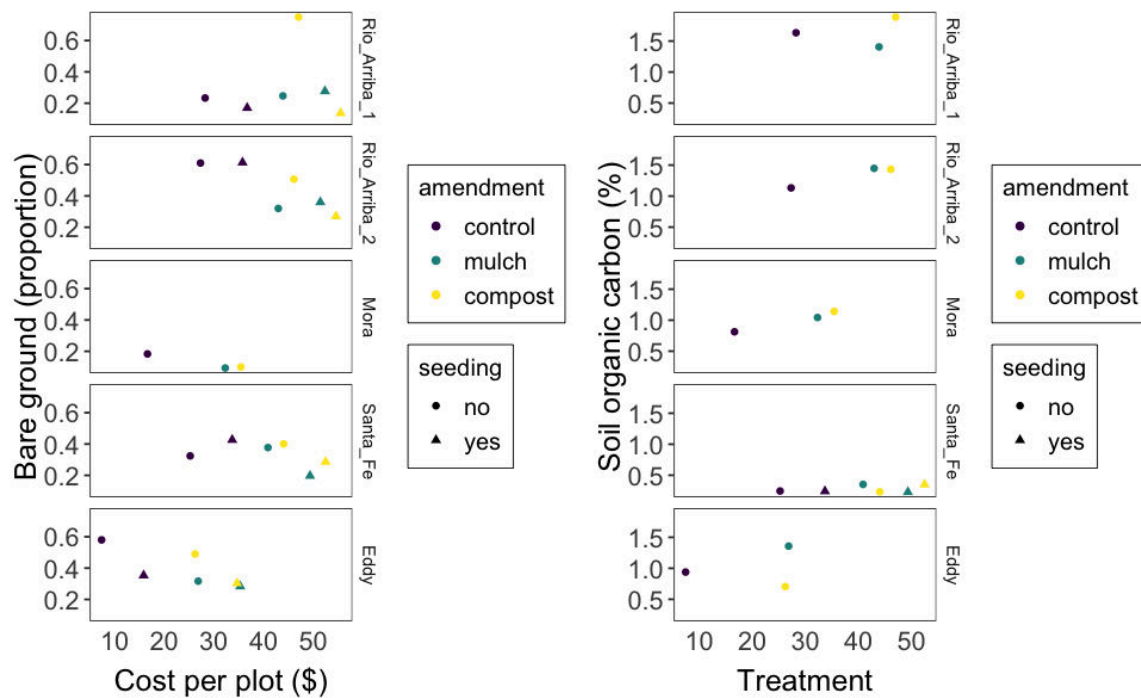
Figure 9. Cost of treatments (amendment = point colors and seeding = point shape) at each ranch. Left column: The amount of bare ground plots upslope of the erosion control structure after one year. Right column: Plant richness (number of species encountered on the line intercept transect) in plots upslope of the erosion control structure after one year.
